Esthetic and Predictable Treatment of Abfraction Lesions

This type of lesion is common in today's patient population, opening up a new avenue of restorative treatment.

By Robert Marus, DDS

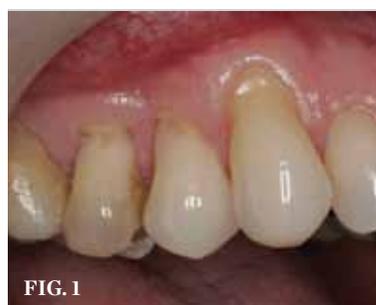
FIG. 1

LESION FORMATION (1. AND 2.) As enamel rods flake away, dentin is exposed and continues to receive the focused flexural stress, creating the V- or wedge-shaped pattern.

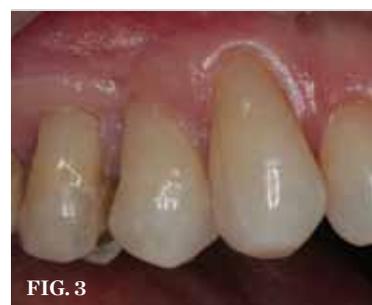
FIG. 3

RESTORATION (3. AND 4.) The proximity of the curing light during placement of a Class V restoration should be close enough to ensure an adequate depth of cure.

flowable composites, such as Venus® Diamond Flow (Heraeus, www.heraeus-dental-usa.com), enables the author to place this material in only two to three increments with improved marginal integrity. The low shrinkage stress of Venus Diamond Flow composite, combined with the lower C-factor of a Class V restoration,¹⁵ may allow for bulk filling of this class of restoration. The close proximity of the curing light in a Class V restoration during placement should ensure an adequate depth of cure regardless of shade (Figure 3 and Figure 4).

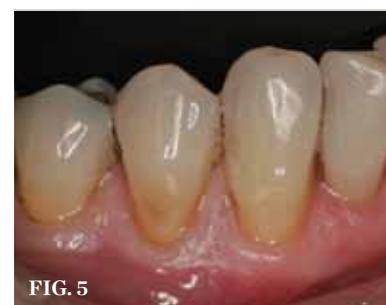
FIG. 5

LESION REMOVAL (5.) Exposed dentin from an abfraction lesion on teeth Nos. 27 and 28. **(6.)** Caries was removed with a slow-speed round bur and all sharp line angles were smoothed and beveled.

A 46-year-old man presented to the author’s office for his routine dental hygiene visit, but had a chief complaint of cold sensitivity in the lower right quadrant. Physical and radiographic examination revealed that the source of sensitivity was the presence of exposed dentin from an abfraction lesion

on teeth Nos. 27 and 28 (Figure 5). The patient was scheduled for operative treatment of these teeth. Venus Diamond Flow composite was selected as the restorative material.

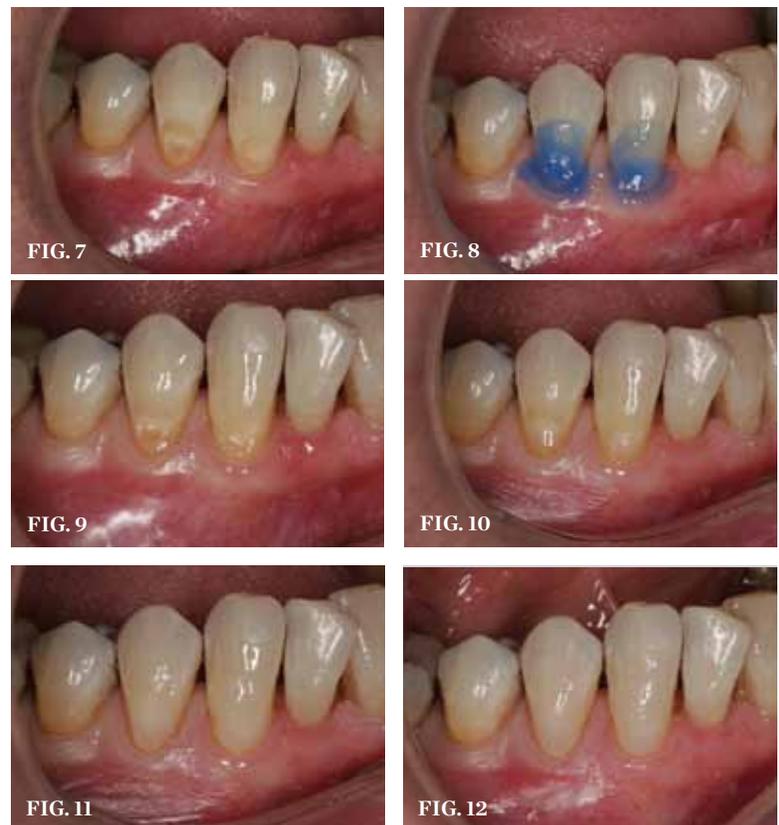
RESTORATION AND FINAL RESULTS(7.) The facial surfaces of the teeth were mechanically etched. **(8.)** The teeth were then acid-etched for 15 seconds and rinsed thoroughly. **(9.)** The bonding agent was placed, thinned, and dried thoroughly. **(10.)** Using a periodontal probe as a placement instrument, the flowable composite in shade opaque medium was applied to the preparation. **(11.)** Two additional increments of flowable composite (shade A2) were placed in a similar fashion covering the cervical and middle thirds of the teeth. **(12.)** A thin layer of sealant was placed and light-cured for 20 seconds to serve as a final “clear coat” for the final restorations.

The facial surfaces of the teeth were then mechanically etched with the MicroEtcher II (Danville, www.danvillematerials.com) (Figure 7) and acid-etched with Ultra-Etch® 35% phosphoric acid (Ultradent Products, www.ultradent.com) for 15 seconds and rinsed thoroughly (Figure 8). The use of mechanical etching is very effective in providing a meticulously clean surface before acid-etching and bonding. Also, because the dentin in an abfraction lesion is typically sclerosed, the ability of restorative materials to bond well

When the acid-etching was complete, the bonding agent was placed using iBOND® Total Etch (Heraeus), which was thinned and dried thoroughly (Figure 9). Then, using a periodontal probe as a placement instrument, Venus Diamond Flow flowable composite shade OM (shade opaque medium) was applied to the preparation (Figure 10). It is important to re-create the dentin with a more opaque composite, because this is consistent with the anatomical nature of the cervical area of the tooth.¹⁴ Two additional increments of Venus Diamond Flow (shade A2) were placed in a similar fashion covering the cervical and middle thirds of the teeth (Figure 11). Finishing at the gingival margin was performed with a Brasseler 8392 30- μ m gingival finishing bur, as any excess composite at the gingival margin would promote gingival inflammation. Polishing was accomplished with both pink and green Venus® Supra polishing cups (Heraeus). A thin layer of Palaseal® (Heraeus) was placed and light-cured for 20 seconds to serve as a final “clear coat” sealant (Figure 12). Finally, the occlusion was evaluated with articulating paper and any excessive occlusal contact was reduced, paying attention to occlusal prematurities. An occlusal guard was fabricated for the patient to wear at night.
